PHASE I ENVIRONMENTAL SITE ASSESSMENT

PALM HARBOR GOLF COURSE

20 PALM HARBOR DRIVE

PALM COAST, FLAGLER COUNTY, FLORIDA

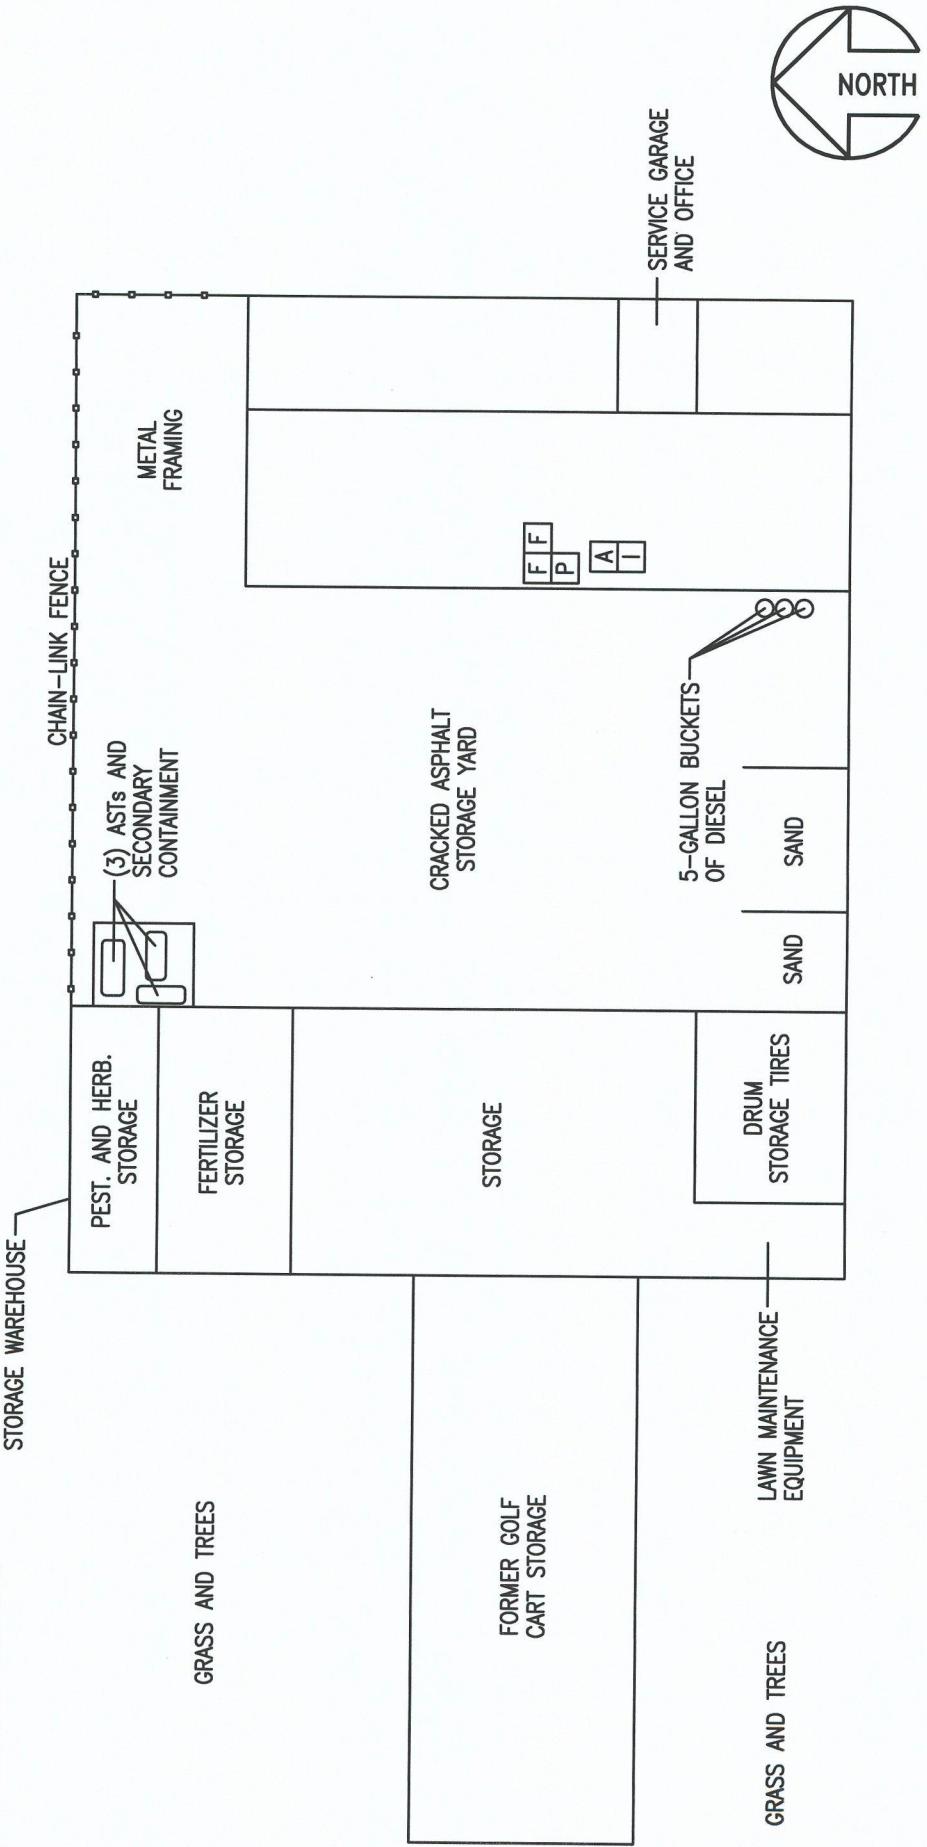
FIGURE 3 - MAINTENANCE FACILITY LAYOUT

- [F] FLAMMABLE LOCKER
- [P] PARTS CLEANER
- [A] ABOVEGROUND LIFT
- [I] IN-GROUND LIFT

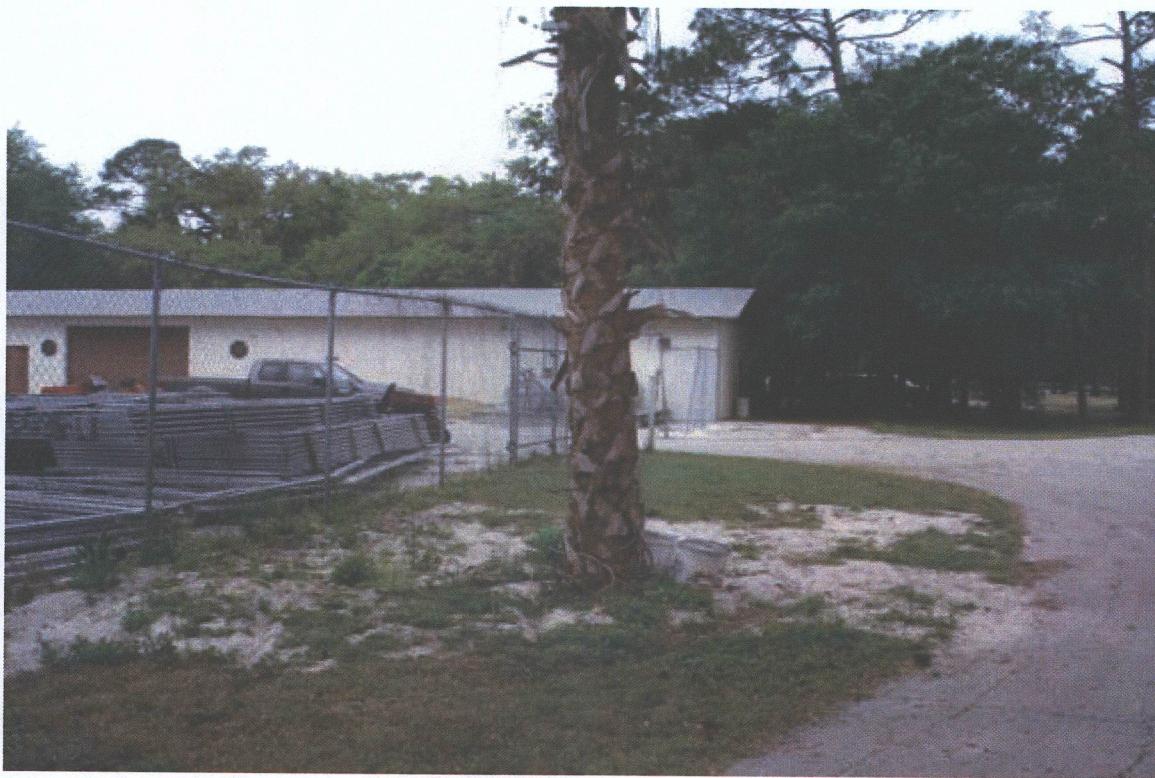
1. View of the maintenance facility on the eastern portion of the site.

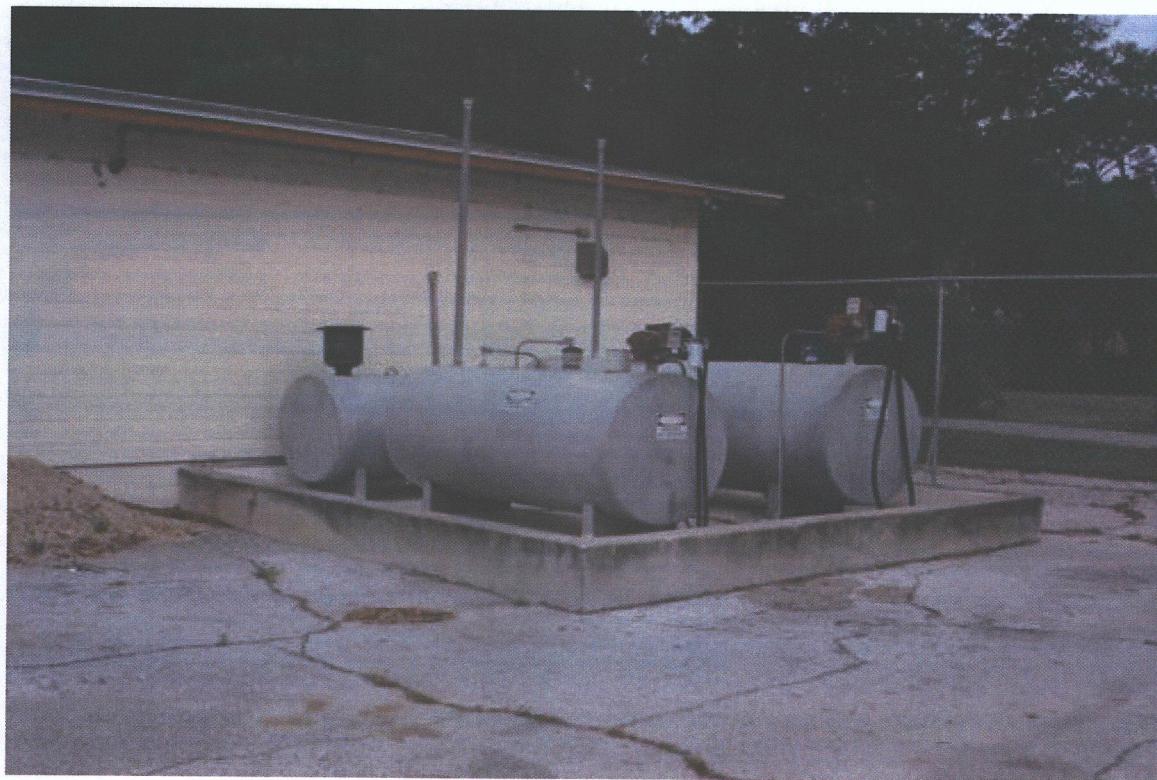
Three ASTs containing waste oil (250-gallon), diesel fuel (500-gallon), and unleaded gasoline (1,000-gallon) are located adjacent to the east of the 7,230-square foot storage warehouse. The ASTs are situated inside a concrete secondary containment system. No stained concrete or unusual odors were noted in the area of the AST system. An emergency shut-off for the AST system was observed mounted on the exterior eastern wall of the storage warehouse. Eight five-gallon buckets and one 10-gallon drum containing used diesel and fuel oil were observed adjacent to the west of the service garage. No stained asphalt was observed in the area of the buckets. The used diesel/fuel oil originated from the maintenance equipment that was sold and removed from the site. Two large mounds of sand were observed along the southern wall of the maintenance compound. The sand appeared to be utilized for the filling of divots in the sand traps located throughout the golf course. Cracked asphalt parking/outdoor storage area was observed between the storage warehouse and the service garage. Numerous abandoned monitor wells were observed adjacent to the northwest of the golf course maintenance compound in the area of the former UST system. The abandoned monitor wells were utilized during assessment activities for the delineation of contaminated groundwater associated with a petroleum release that occurred in March 1992. Eight pad-mounted transformers were observed throughout the subject property. No stained soils or stressed vegetation was observed in the areas of the transformers.

2. View of the ASTs located at the maintenance facility.

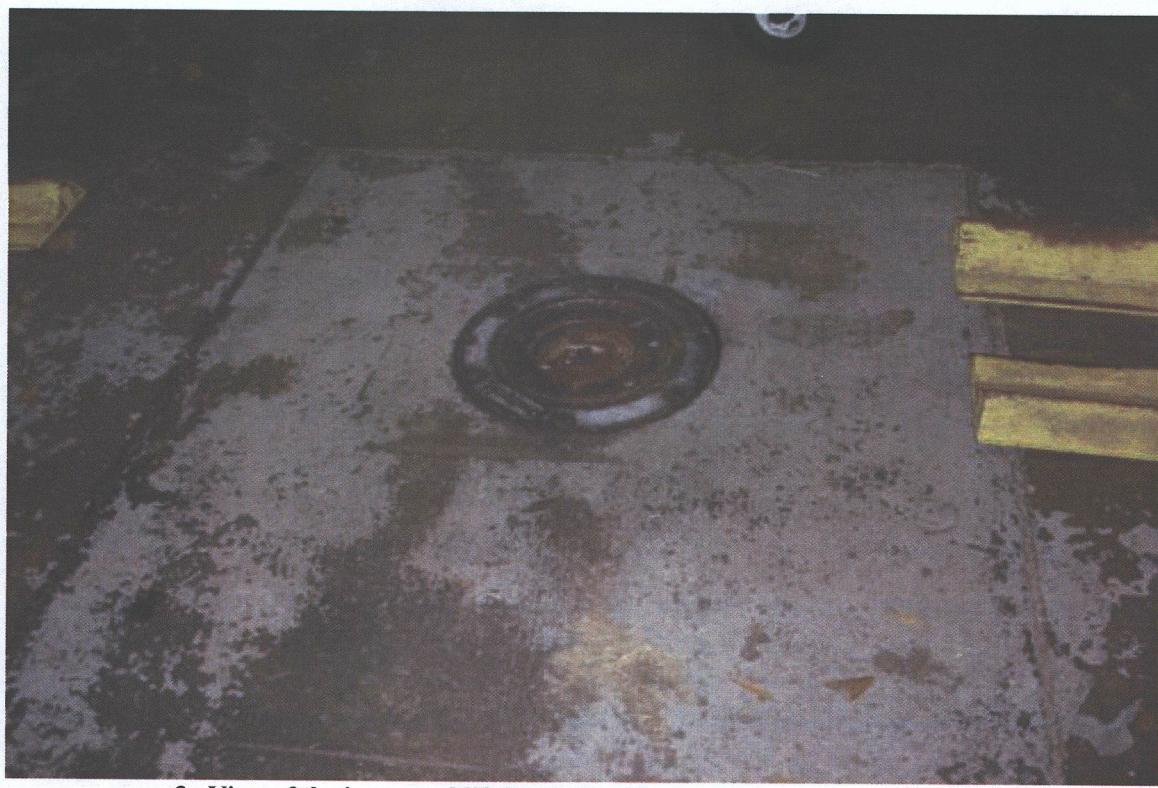
- Potential onsite concerns were noted from the use of the subject property as a golf course from at least 1970 to the present and from historical and current applications of herbicides and pesticides for the maintenance and upkeep of the fairways, tee boxes, and putting greens.
- Potential onsite impacts were noted from the in-ground hydraulic lift located inside the service garage of the maintenance compound. According to Mr. Lorenzo Butler, Maintenance Supervisor, the in-ground hydraulic lift was installed in the 1980s with the construction of the service garage; however, use of the in-ground lift was discontinued when the aboveground lift was installed in 1999. Mr. Butler stated that the hydraulic oil reservoir for the in-ground lift is still in-place and that he was not aware that the hydraulic oil was ever removed.

3. View of the in-ground lift located inside the service garage structure.

MATANZAS recommends limited soil and groundwater sampling of the fairways, tee boxes and putting greens to evaluate the potential impact to soil and groundwater associated with the historical and current use of herbicides and pesticides. MATANZAS also recommends closure of the in-ground hydraulic lift and removal and proper disposal of any residual hydraulic oil. In addition, a soil and groundwater sample should be collected during the closure of the lift to evaluate the potential for the soil and groundwater contamination associated with the lift.

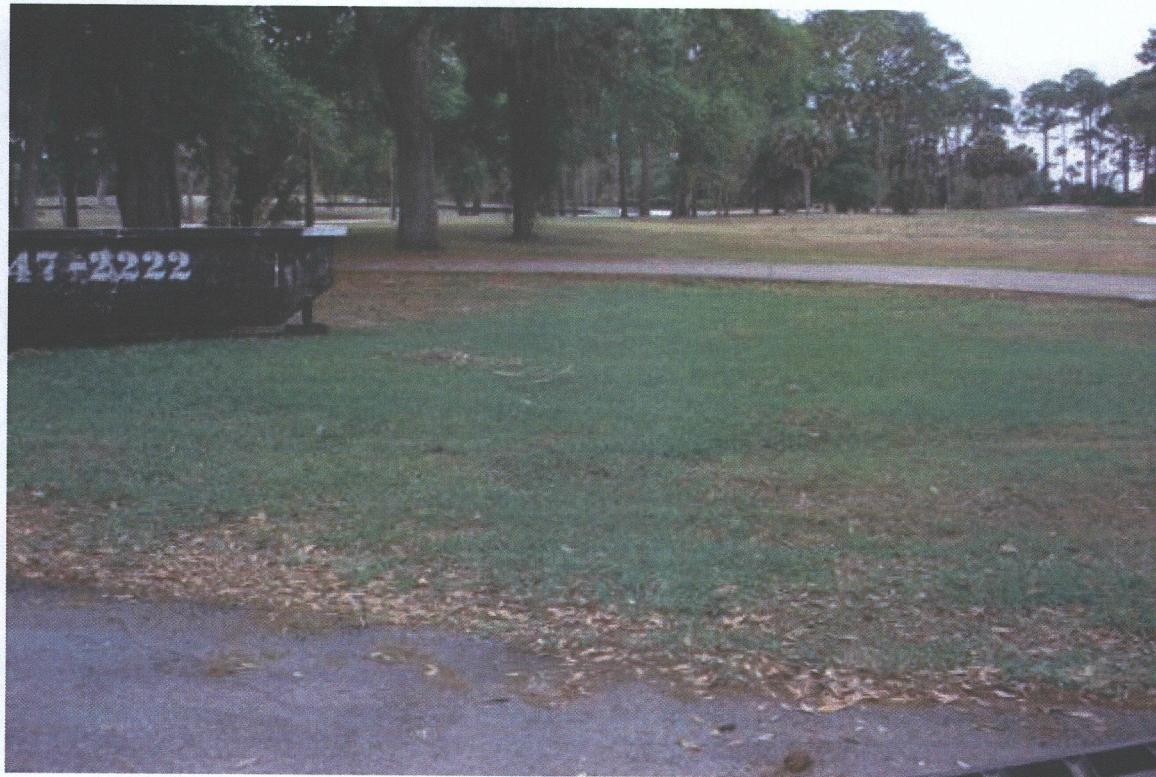
Palm Harbor Golf Course, Cooper Drive, Facility ID#8628128: This UST/AST/LUST facility is located at the subject property. According to the database report, two 500-gallon USTs containing waste oil and diesel fuel were removed in March 1992. One 250-gallon AST containing waste oil, one 550-gallon AST containing unleaded gasoline, and one 1,000-gallon AST containing diesel fuel are currently in service. According to a Storage Tank Facility Annual Site Inspection Report, dated January 29, 2007, the ASTs and secondary containment were in good condition and the facility was in compliance. A discharge for this facility was reported to the FDEP on March 1, 1992; the facility was issued a site score of 9; and the facility was eligible for state-funded cleanup under the Petroleum Liability Insurance and Restoration Program (PLIRP). The USTs, piping, and dispensers were removed in March 1992 along with 20 cubic yards of soil. Additional source removal activities occurred in late April and early May 2005, which included the excavation of 2,056 tons of contaminated soil, dewatering and proper disposal of contaminated groundwater, introduction of ORC Advanced amendment, post excavation sampling, site restoration, and post excavation groundwater sampling. According to a Natural Attenuation Monitoring Report, dated December 12, 2005, two consecutive rounds of groundwater sampling reported petroleum constituents below their respective state cleanup target levels and Site Rehabilitation Completion Order (SRCO) was requested. On February 3, 2006, FDEP approved and issued a SRCO for this facility. Based on the information obtained during this investigation, this facility is not suspected of negatively impacting the subject property at this time.

4. View of the former UST tank farm.
